## KAYTECH CASE STUDY

# SUSTAINABLE COASTAL PROTECTION AT SITU ISLAND RESORT

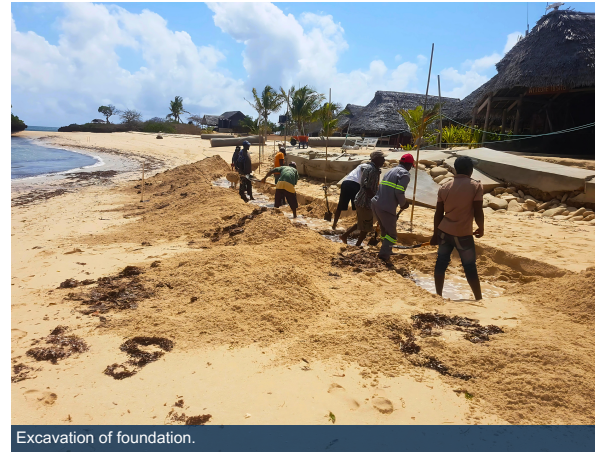
Excavation of foundation.

- **Installation:** A foundation, 1.8m wide by 50m, long was excavated during the receding tide. The composite geotextiles were placed and filled with sand using spades and wheelbarrows, then water-compacted. The cover layer was sewn into place before the high tide.
- **Formwork and Support:** The layers were contained within a frontal formwork, with support brackets featuring long flat sections placed between overlaying and underlying geocomposite tubes for stability. These brackets were removed once the tubes were filled and sewn.

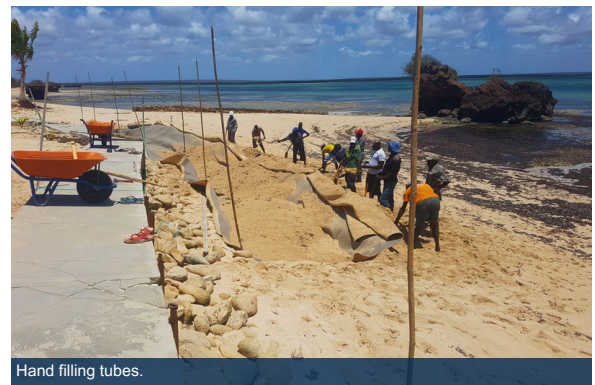
Hand filling tubes.

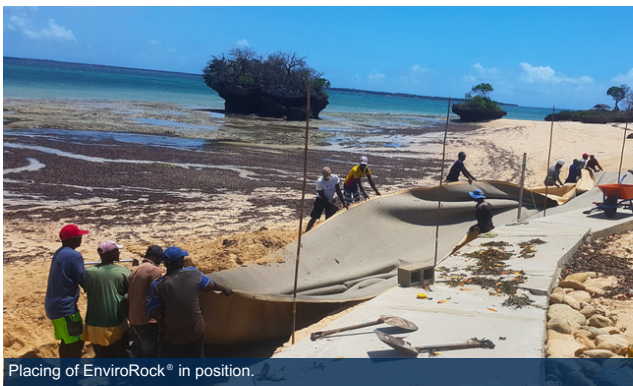
Placing of EnviroRock® in position.

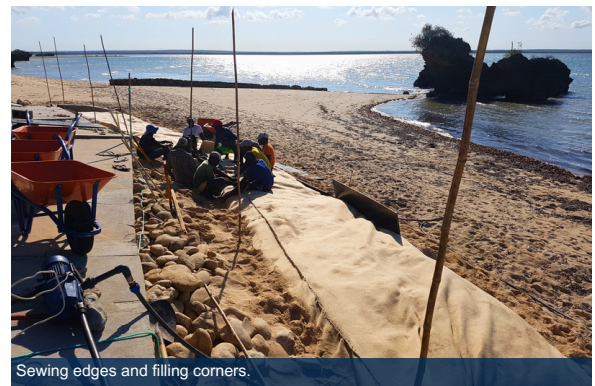
Sewing edges and filling corners.

- **Fabrication:** EnviroRock® geocomposite tube structures were assembled in 4.6m wide by 50m rolls, with each layer set back 750mm and measuring 1.8m in width. The composite geotextiles were hand-sewn along the edges and back, with holes thermally penetrated 25mm from the edge for sewing closures.
