## KAYTECH CASE STUDY

# SOLVING WATER INGRESS CHALLENGES WITH A FLODRAIN® SYSTEM: A COST-EFFECTIVE SOLUTION

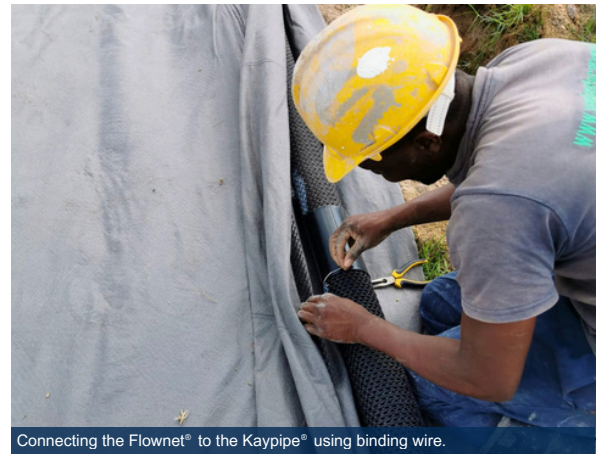
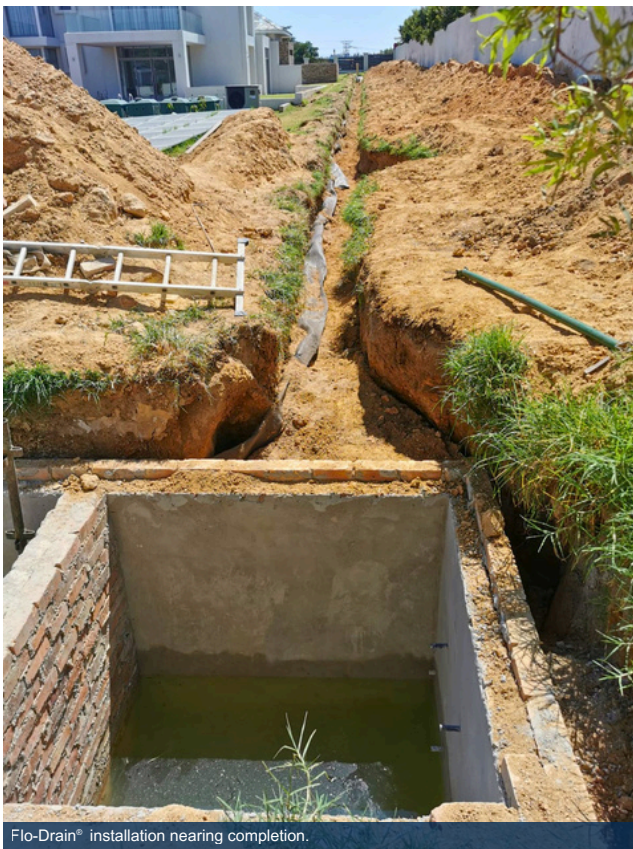
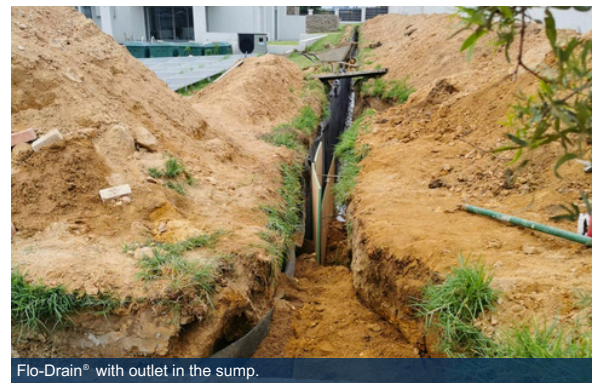
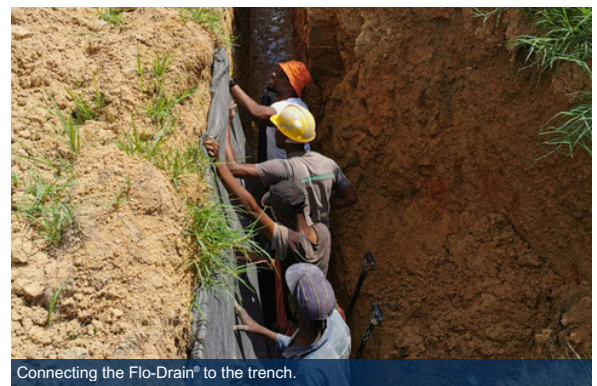
- 1. System Installation:** The Flo-Drain® system was installed 2.4 meters underground to ensure that water did not flow underneath the drain and into the structure. A 70-meter trench was excavated across the upper section of the property to accommodate the Flo-Drain®.

- 2. Filtering Mechanism:** To enhance the performance of the Flo-Drain® system, a 100mm layer of river sand was installed as a secondary filter on the upstream side of the bidim®. This separation layer effectively separated the in-situ backfill material from the bidim®, preventing any potential clogging issues and ensuring the system's long-term functionality.
